Report of Marine Survey

Splash of Wrong

34 Cobia

December 14, 2022

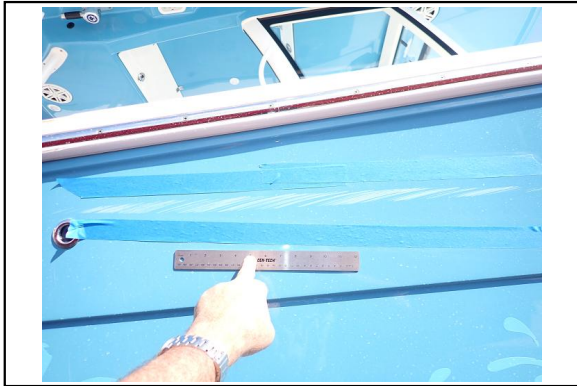
EXTERIOR HULL: Powder Blue Gel coat topside's with a white gel-coat bottom, the exterior hull's surface was in good condition took percussion readings every eight (8") inches along the topsides. Below the waterline, no significant voids or delaminations were found. A Protimeter Moisture Meter was also used to perform readings around the thru-hulls, running gear, and adjacent wetted surfaces; no significant conductivity (moisture) was cited. On the bow under the anchor and the Starboard side in the aft area just forward of the transom, there are gel-coat chips down to the fiberglass. On the Starboard side about amidships, there is a significant Six (6') foot scrape in the Gel-coat That cant be buffed out. A swim door located on the Starboard side was serviceable sealed as designed and worked when opened and closed.

Starboard side scrapes 1

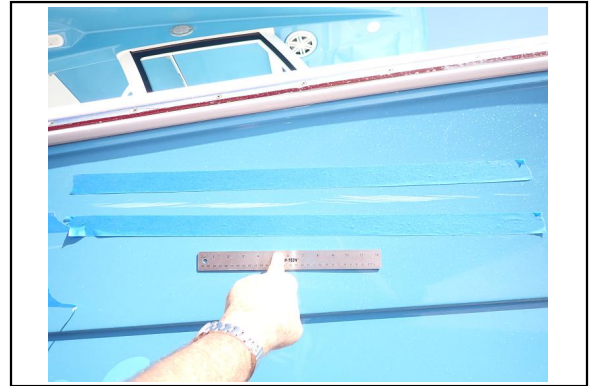
Scrapes 2

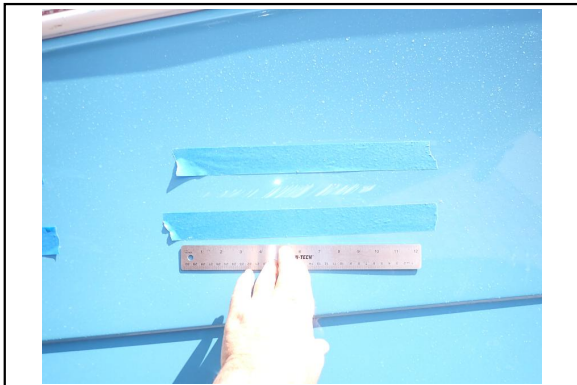
Scrapes 3

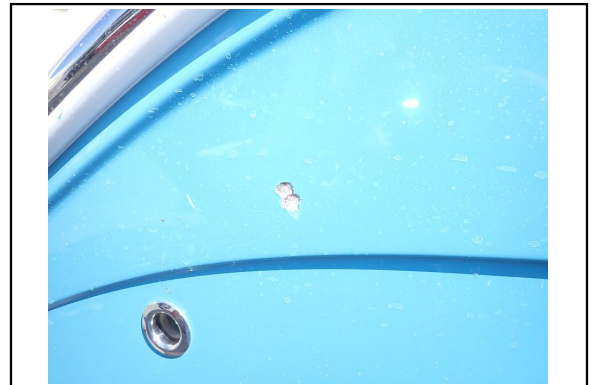
Gel Coat chip

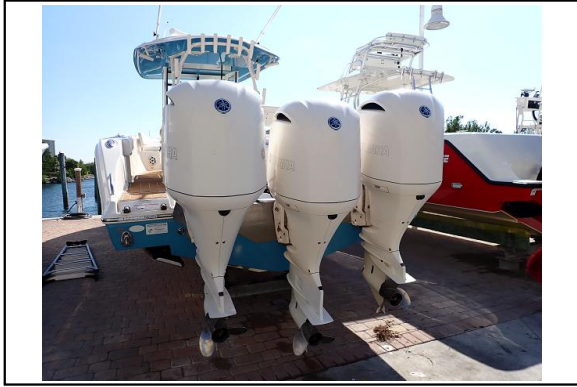
Transom

TRANSOM: The transom was percussion tested using a phenolic hammer every eight (8") inches, and no significant voids or delaminations were present. In addition, I tested the transom for conductivity (moisture) using a Protimeter moisture meter; no significant conductivity was noted. A Stainless Steel bracket that holds the outboards to the transom was serviceable, no cracks or rusting was visible when tested buy shaking the outboards no flexing was noted.

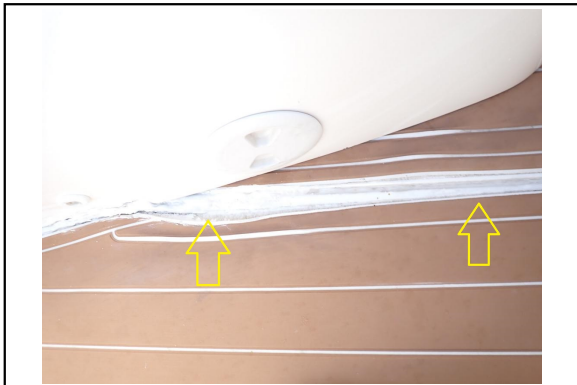
- * **COCKPIT: [C1]** The cockpit or deck layout had a synthetic resin-based teak-looking laminate glued to the FRP (Fiber Reinforced Plastic) deck is serviceable except for a tiny area next to the forwardmost cooler where the water drain has some lifting effect. Four large storage compartments along the sides and a large compartment in the aft area are serviceable and were tested by opening and closing. The caulking that makes the deck watertight is past its serviceable life and should be redone.

bad caulking

Recommend striping old calking out around the center console and replacing with good silicon and then gluing the flooring back down to keep it from peeling up.

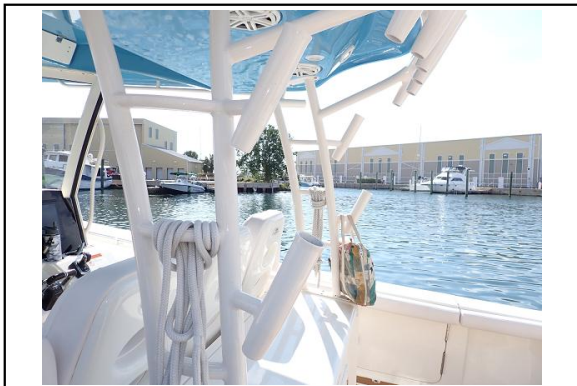
TACKLE STATION: The Tackle station directly behind the helm station and crew seats has a small working sink with plenty of storage drawers and a cutting board with light use is clean and serviceable as sighted. One (1") inch piping uprights with rod holders are supports for the hard top are powder coated white are serviceable clean and show little corrosion.

Supports for hard top

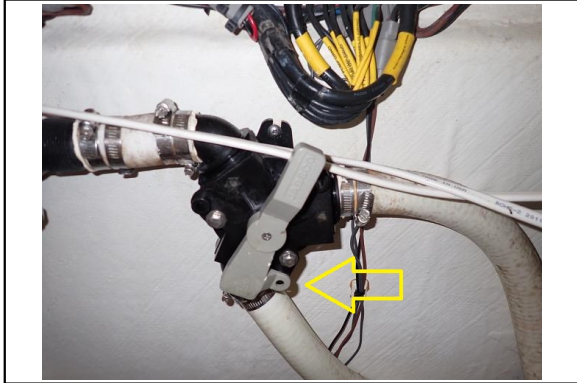
* **ACCOMMODATIONS: [A1]** As you climb down into the cabin from a door on the port side, there is a double berth with a cushion that is serviceable, as sighted on your left. Looking forward, there are drawers for storage that are clean and open and close when tested. Above the drawers are the DC battery panel and switches. Just to the right of the drawers is a RARITAN electric head that worked when tested for power-up. The freshwater sink was just to the right as you head down into the cabin, was serviceable, and worked when powered up. On the aft bulkhead is the access hatch for the helm and electronic equipment worked when opened up. Inside that hatch was very tidy and professionally put together from an ABYC standpoint. Just below that hatch is a compartment that holds the Y-Valve for the overboard discharge, amidship bilge pumps, the AIRMAR transducer, and the macerator for the head tank.

Y-Valve

FINDINGS	RECOMMENDATIONS
A.1 (PAGE 11) ACCOMMODATIONS: Y-Valve was not locked into the closed overboard position	<i>Under 46 CFR 159.7 using a non-releasable wire-tie to hold the y-valve in the closed position.</i>
A.2 (PAGE 15) STORAGE TANKS: Water tanks contain dirty water that smells bad.	<i>Recommend following suggested method of disinfection in ABYC H-23 Fill entire system with a chlorine solution having a strength of at least 100 parts per million and allow to stand for one hour then drain and flush with good potable water.</i>
A.3 (PAGE 17) NOTE: Although the valves on the thru-hulls worked when tested some were hard to open.	<i>Recommend all valves connected to the thru-hulls be inspected and serviced to insure continued service.</i>
A.4 (PAGE 17) NUMBER AND TYPE OF PFD'S: Boat is registered as a charter company and does not comply with 33 CFR Part 25	<i>If new owner plans to charter, the vessels Life saving equipment must meet all of the requirements found in 33 CFR part 25.</i>

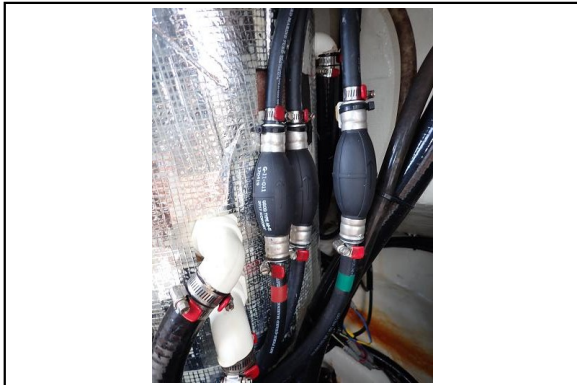
FUEL LINES AND FITTINGS: All fuel lines that were visible for inspection are A1-15 USCG approved hose and squeeze balls meet requirements found in CFR-33 Subpart J 183.540 and recommendations found in ABYCH-24.

Fuel lines

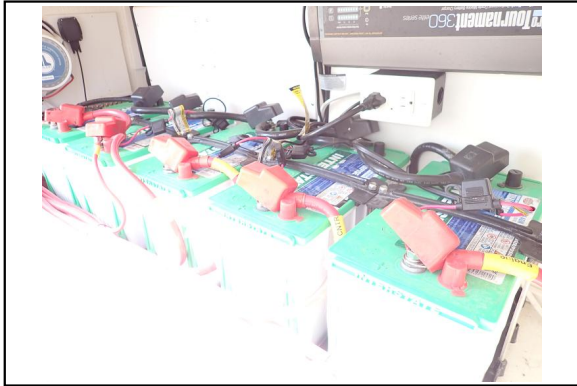
VOLTAGE: Five Interstate 12 volt battery's recently introduced in October 2022 located under the helm bolster seat meet all recommendations found in ABYCE-10.

Battery's

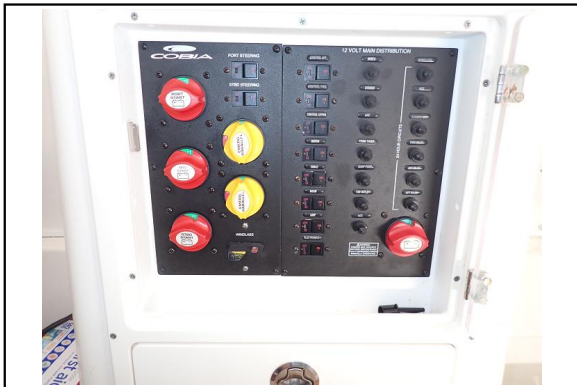
MAIN BATTERY SWITCHES: Located in the head are serviceable and meet recommendations found in ABYCE-11

Main Battery switches

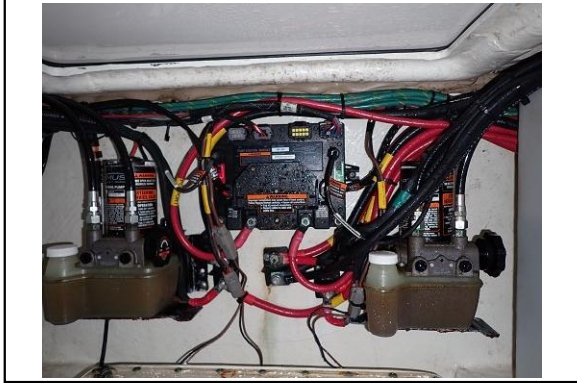
- * **TYPE: [B1]** One (1) Sea Star Classic tilt Helm station connected to Two (2) OPTIMUS Sea star assist pumps Serial numbers 12-106835 and 12-106830 connected to a Pump Control Module using factory supplied hoses connected to two (2) hydraulic Sea Star rams on the Starboard and center outboards worked as designed when tested during in water testing.

Sea Star helm system

FINDINGS	RECOMMENDATIONS
B.1 (PAGE 16) TYPE: Salt spray accumulation was visible on electronic units	<i>Recommend desalting and clean very gently around the electronic pump control unit.</i>

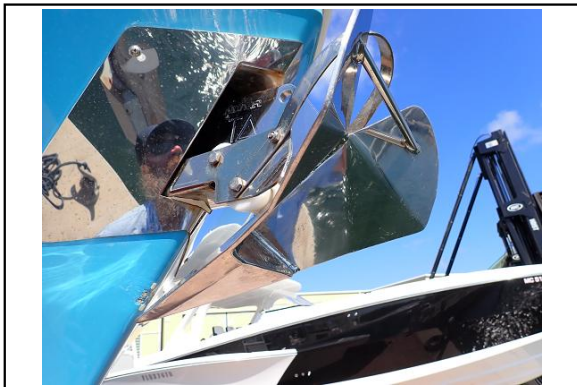
- * **ANCHORS: [C3]** One (1) Stainless Steel LEWMAR plow anchor with approximately 20 feet of galvanized chain and 150 feet of 5/8 nylon 3 strand road attached in the bow is serviceable and capable of holding the boat during a day trip.

Plow Anchor

Recommend a spare danforth and chain with road be introduced onboard to handle the different conditions that might arise in the Keys.

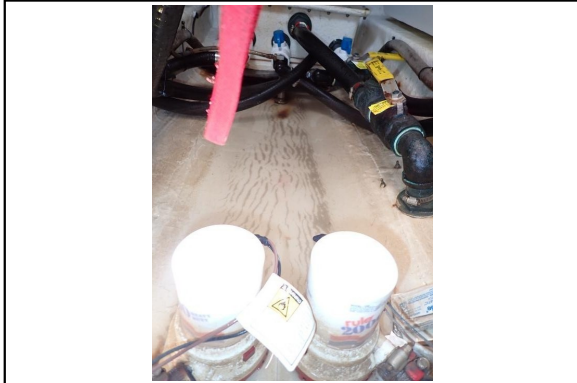
LIST: Three (3) 2000 GPH Rule Bilge pumps Two (2) located in the aft bilge and one located in the center bilge are serviceable and all worked when tested manually and float switch.

Aft Bilge Pumps
