Report of Marine Survey

Splash of Wrong

34 Cobia

December 14, 2022

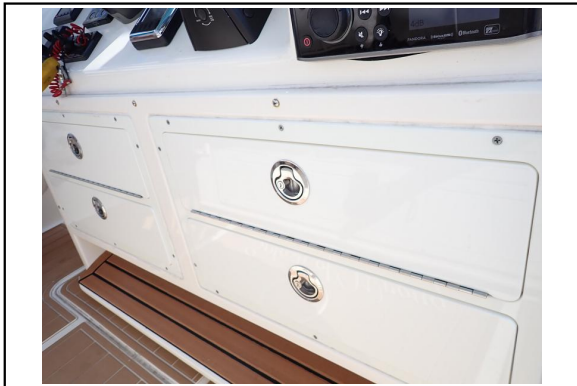
CC storage

TYPE: Center Console provides helm station crew seating with a hard top and glass windshield with a working wiper and an electric hydraulic window opener that all worked when tested for power up. plenty of cabinets for storage both in the hard top and under the helm station all compartments were clean and worked when opened and closed. recessed lighting and speakers in the hard top all worked when tested for power up. The seats are white pleather marine material showed little use are serviceable and worked when tested for fold up abilities.

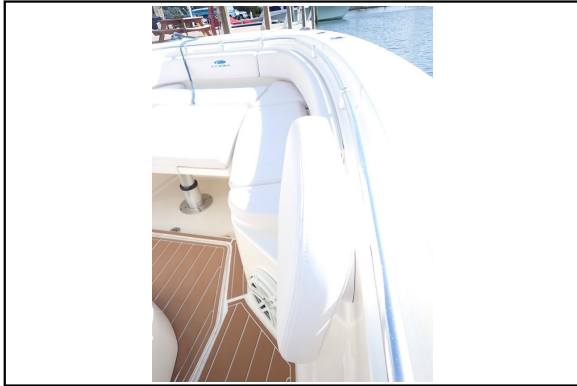
Forward seating and table

GENERAL EQUIPMENT: Forward Table and seating area is serviceable with little use and worked when tested by lifting and lowering table and back rests.

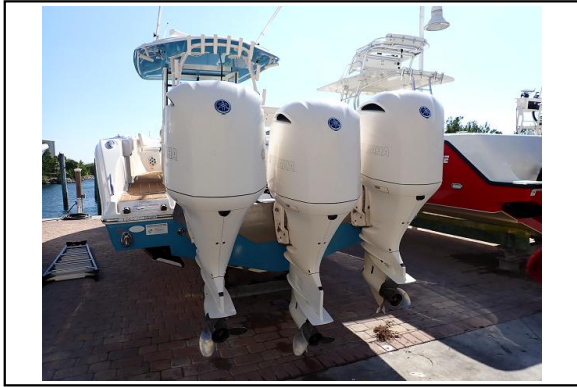
Transom

LABELS AND NOTICES: All Labels and notices are present on the transom and helm station that meet ABYC STANDARDS S-7, S-30, and T-8.

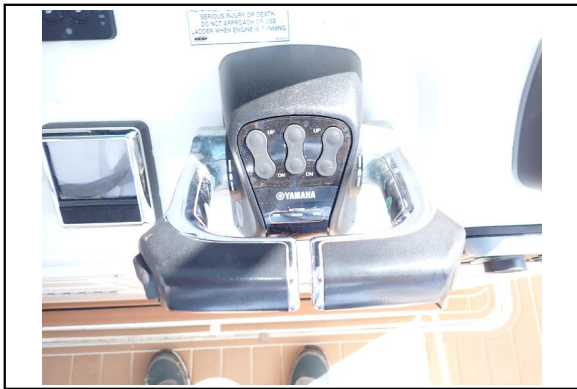
Throttle control

THROTTLE CONTROLS: Yamaha ECU (Electronic Control Unit) with joystick control for docking.

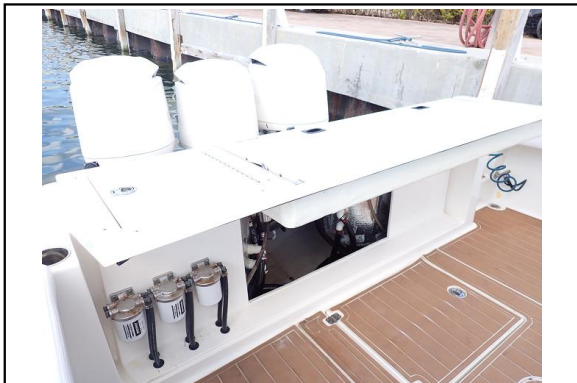
Fuel Filters

FUEL FILTERS: Three (3) Quicksilver 35-8M0154752 water separating Fuel filters are located in the starboard side of the aft live well compartment for easy access are serviceable.

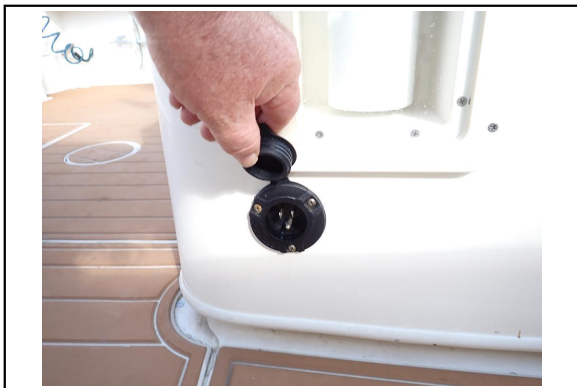
Shore plug

SHORE POWER INLET: 110 Shore power connection is located on the Starboard side base of the helm seat was serviceable but was not tested during survey.

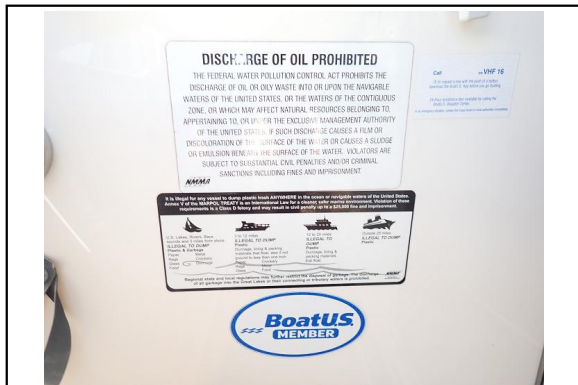
Play cards

"NO OIL DISCHARGE" PLAQUE: Yes, found properly displayed in the head compartment door.
